Downeast Credit Union: *Implementing Town Character Standards*

by Randall Arendt

Location: 94 Main Street, Topsham, Maine

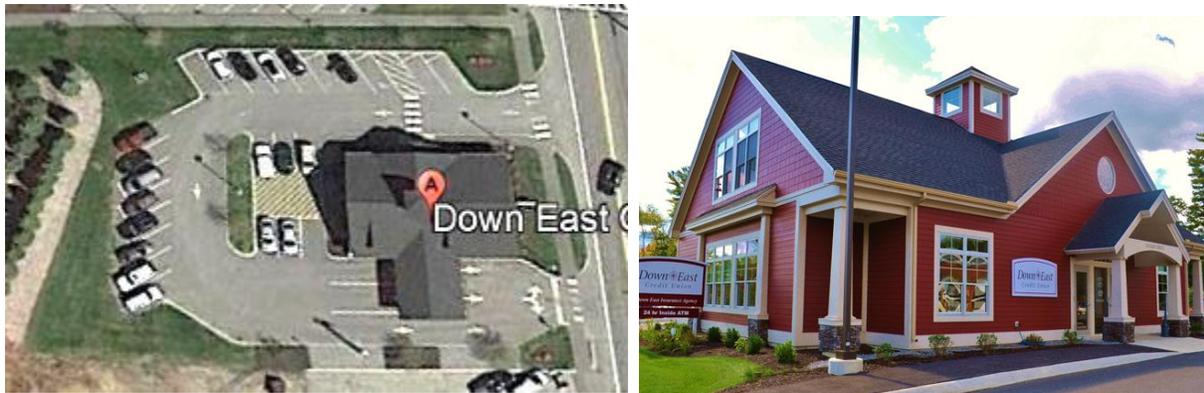
Figure 1: The above aerial photo shows the credit union's very close relationship with Main Street, just enough for landscaping and a wooden sign. Because most of the parking is located in the back, the town allowed a side entrance, shown above. (Photos courtesy of Google Earth and the Priority Real Estate Group)

This bank was one of the first projects to implement Topsham's design standards requiring new buildings to be located closer to the street and to have second stories and formal elevations facing the street. It is also adjacent to the town's offices and public safety building which were constructed three years prior to the credit union. All three structures create the more traditional look that the town had adopted through the implementation of their Main Street Planning efforts in 2008, a design approach that is evident in a number of new buildings in the Lower Village, 1.5 miles to the south, also along Main Street.

This project has reinforced the streetscape, as it was built on a mostly open lot occupied by a car dealership. The ground floor covers 2,700 square feet of floorspace, while its smaller second floor provides two offices, a large storage closet, a mezzanine, and a restroom. The building's interior design features an opening from the ground floor up to the cupola, which admits additional daylight to both floors.

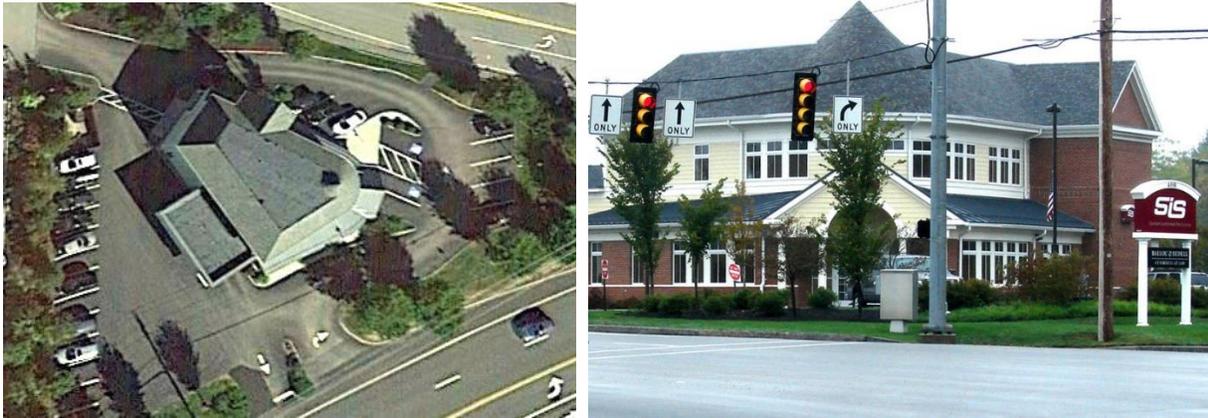
Figure 2: The Sanford Institute for Savings Bank, at the corner of US Route 1 and Maine Rt. 91 in York, Maine, maintains a close relationship with the roadways and provides entrances from both front and back. Its second floor is occupied by a law firm. Its small tower-like roof turret is a special feature recalling a design practice more common in the 19th century to create a grander appearance, signifying the bank's pride in its new buildings. The siting and rear parking follow standards adopted by the town in the early 1980s, at the suggestion of the author.

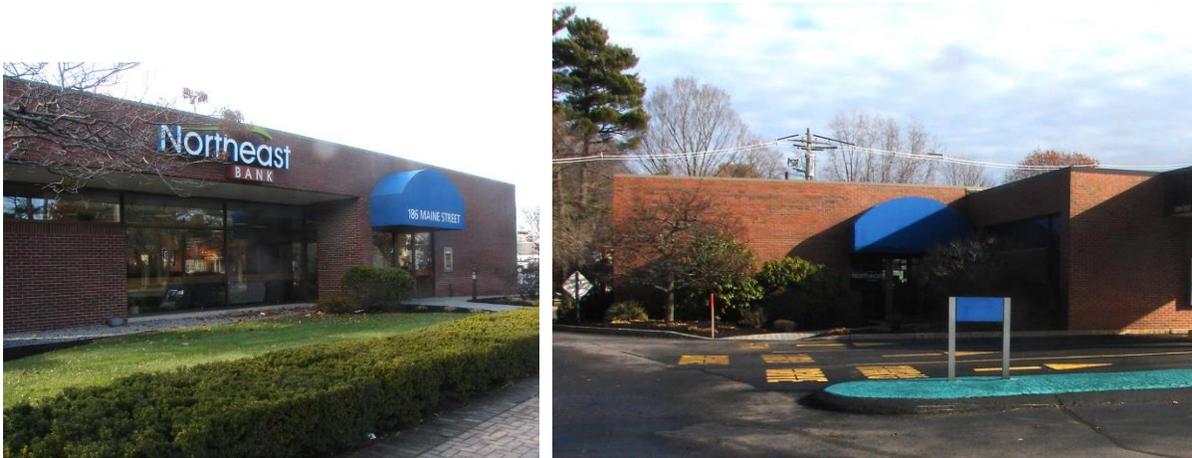
Figure 3: The Northeast Bank Brunswick, Maine has entrances facing both Maine Street in front and the parking lot in the back, creating a doubly convenient situation for its customers.

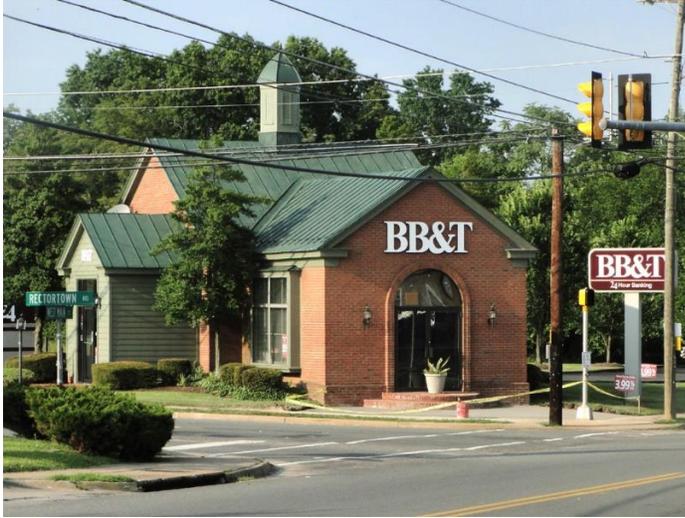
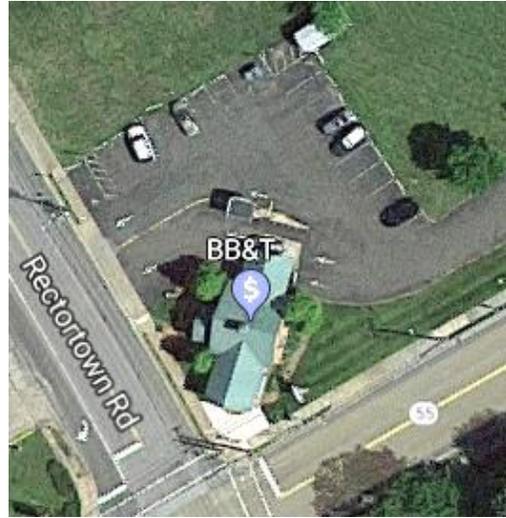
Figure 4: The BB&T bank at the principal corner in the village center of Marshall, Fauquier County VA, combines a neo-traditional appearance with close proximity to both streets. Its side entrance is convenient to Rectortown Road and the rear parking lot.
