Greenwood Trades Building:

Woodworking Shop and Commercial Space in a Customized, Metal-clad Building

by Randall Arendt

Location: Greenwood Road, Brunswick, Maine

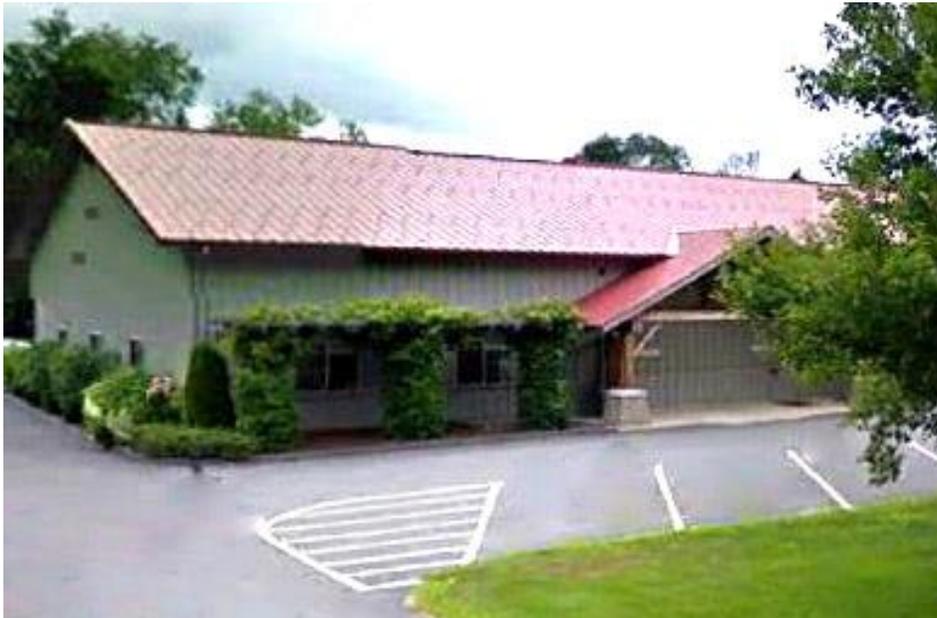
Figure 1. This photo shows the western end of the building with one of its two gabled front entranceways and one of its three trellises covered with hydrangea vines.

The 10,300 square foot building features a brownish red metal pitched roof with a 4/12 slope, beige metal-clad walls, and two large gables, one over each of the building's two front entrances. In an inspired touch, Koehler added large wooden trellises (about 22 feet long and eight feet deep) on each side of the twin gables and another one between them. Planted with hydrangea vines that are in leaf from early May through October, and which flower profusely in June, the three trellises and their lush vines have completely transformed this nicely proportioned structure, making it perhaps the most attractive light industrial building in the state.

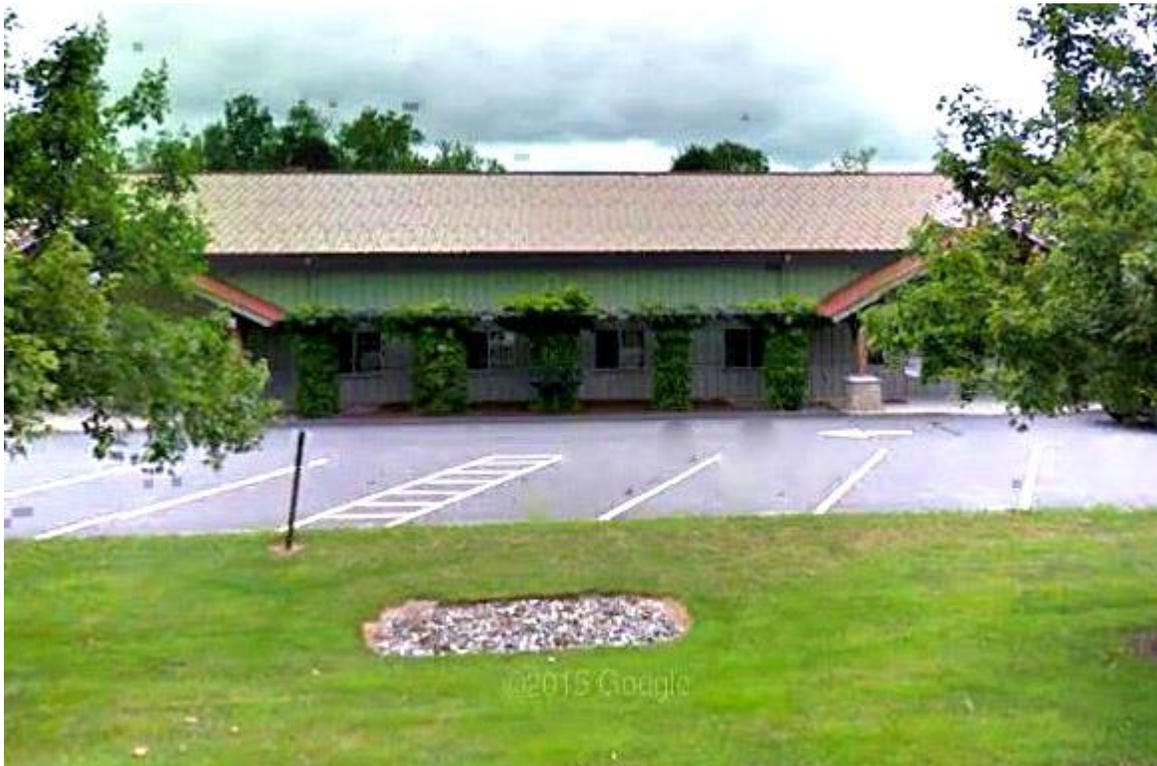
Figure 2. The central trellis shown above is “book-ended” by the building’s two front entranceways. Branches from two of the six maple trees planted along Greenwood Road frame the picture. Parking lot stormwater flows across a

grassy strip to a rock-filled detention area where it infiltrates through the soil which filters it and removes contaminants.

Adding to the traditional streetscape are six maple trees planted 40 feet on center in a grassy landscaped strip, which have matured nicely and help to buffer the small front parking area. The western end of the property, adjoining an existing residence, has been thickly planted with white pines to create visual screening.

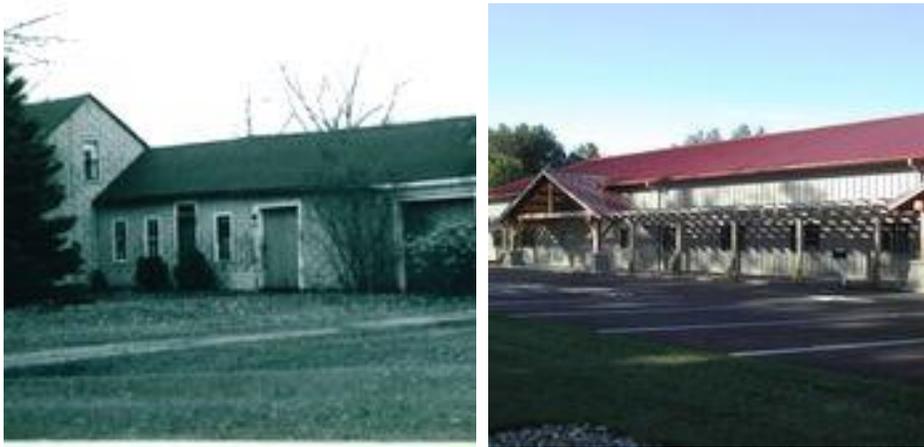
Figure 3. This before-and-after pair shows the original farmhouse (which had reached a state of advanced deterioration when the property was purchased) and the newly-constructed light industrial building, with its gabled entrances and the middle trellis, shortly after the vines were planted. (Photos by Eric Koehler)
